December 17, 2021

Subject: Informal Dam Inspection
Highland Lake Dam
Town of Highland Lake, Alabama
MBA Reference Number: G21-047.00

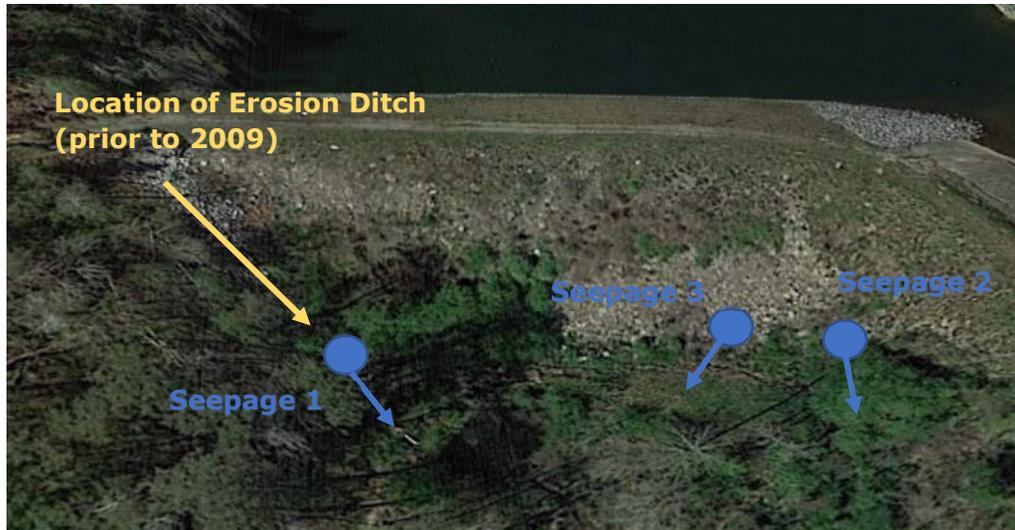
- Downstream Toe Area: The toe area of the downstream slope primarily consisted of large sandstone boulders and no erosion was observed at the slope/ toe contact. No signs of movement or depressions were observed at the toe. Water seepage was observed at three (3) locations (See Figure 2), and the following was noted:

- Seepage 1 observed in the Southwest corner at the toe of the general area of the limestone riprap. Flow at Seepage 1 consisted of approximately 0.5 gals/min. Mr. Hayden stated the seepage from Seepage 1 appears to be a result of water from the western hillside and not from the lake. Prior to installing the riprap, an erosion ditch had been created between the dam and the natural grade due to the constant seepage from the western hillside. In 2009, the drainage ditch at the base of the dam and along the slope were backfilled with limestone riprap by Mr. Hayden to prevent additional erosion.

- Seepage 2 was observed at the location of the abutment corner in the middle length of the downstream slope. Estimated flow consisted 3 gal/min.
 - Additional seepage (Seepage 3) was observed between Seepage 1 and 2. Seepage flow appears to be less than 1.0 gal/min.

- The majority of the toe area consisted of soft, saturated clay. The depth of soft clay is unknown; however, based on probing with a steel rod, the soft conditions extended to at least 3' below the existing surface.

Figure 2: Approximate Location of Observed Seepage at Toe of Downstream Slope

Controlling Water Seepage: As a minimum, water seepage should be controlled so the foundation soils at the toe of the slope do not continue to be saturated. Trench drains should be considered to collect water from the toe of the slope to the existing creek in order to control the water.

Continue Monitoring Water Seepage: As previously discussed, we are unaware of the origin of the water seepage, and the location in the southwest corner maybe seepage from the western hills. We recommend continuously monitoring the seepage to determine if seepage flow is increasing. If seepage flow increases, additional stabilization measures would have to be considered.

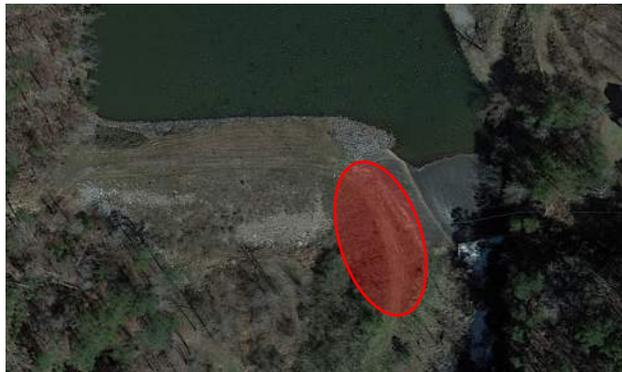
Junctions with Abutments or Embankments: A large (narrow) abutment feature is located between the apron and the downstream slope. The abutment separates the apron from the remaining downstream areas (See [Figure 1](#) for location). The abutment may have been constructed as a roadway to access the bottom of the dam.

[Figure 1](#): Abutment Feature between Apron and Downstream Slope

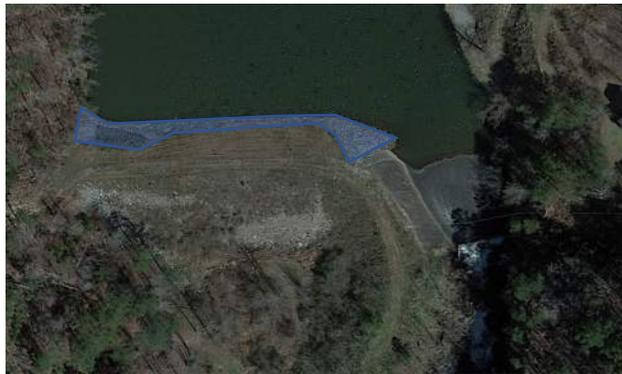
Slope Protection: Majority consists of maintained grass. Riprap is located along the shoreline for wave protection. Riprap is located on western wing, and 30' of riprap is located adjacent to the concrete spill way. No major slope protection issues were observed.

Figure 2: Location of Rip-Rap located on Upstream Slope

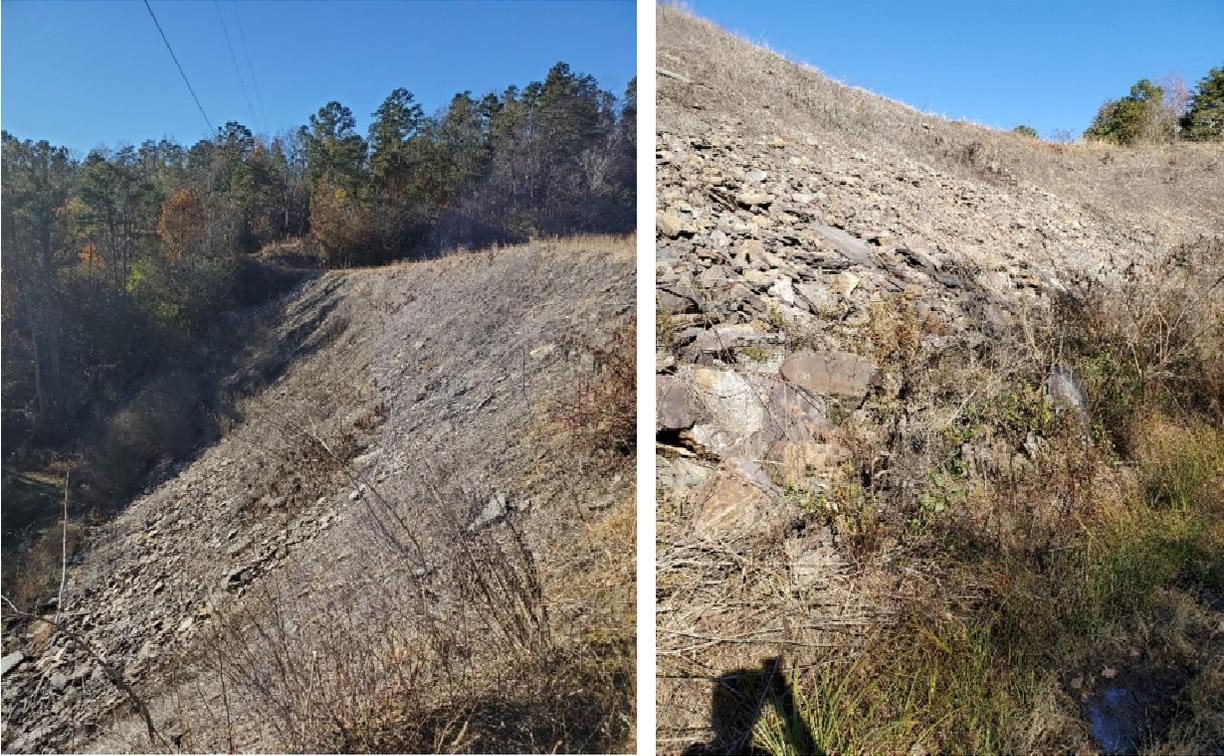
Figures 3 and 4: Downstream Slope Conditions

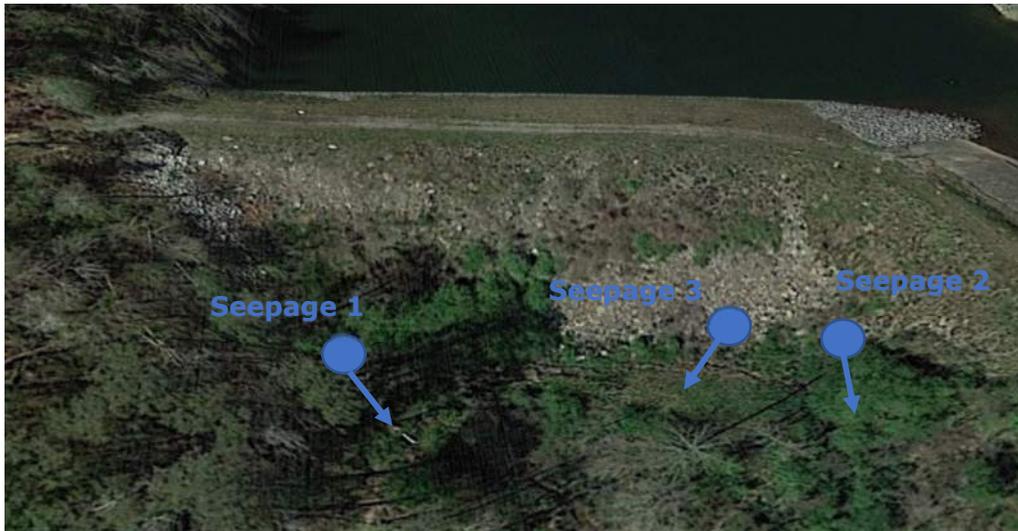
Seepage or Wet Area Along Contact: Figure 5 shows the location of observed seepage. The following was observed at the seepage areas:

1. Seepage 1 observed in the Southeast corner in the general area of the riprap. Estimated flow was approximately 0.5 gals/min.
2. Seepage 2 was observed at the location of the abutment corner in the middle length of the downstream slope. Estimated flow consisted 3 gal/min.
3. Additional seepage (Seepage 3) was observed between Seepage 1 and 2. Estimated flow was less than 1 gal/min
4. The majority of the toe area consisted of saturated clay. I was able to penetrate my 3' probe rod to the handle bar due to soft soils.

Figure 5: Approximate Location of Observed Seepage at Toe of Downstream Slope

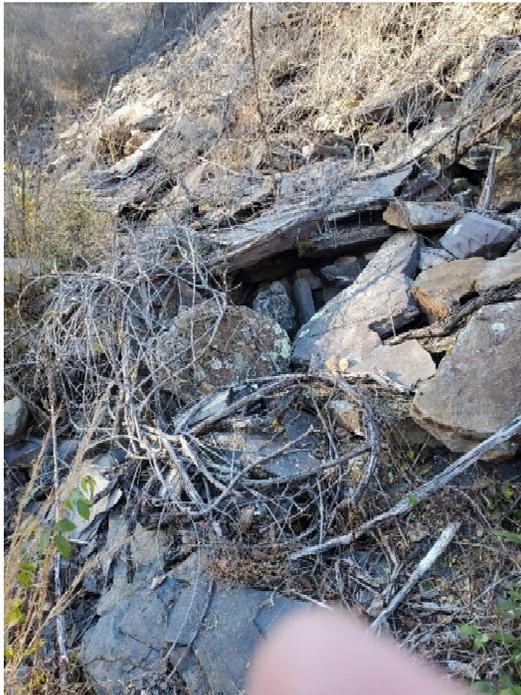
Figure 6: Boulders Located at Toe of Downstream Slope. Picture near Seepage 1

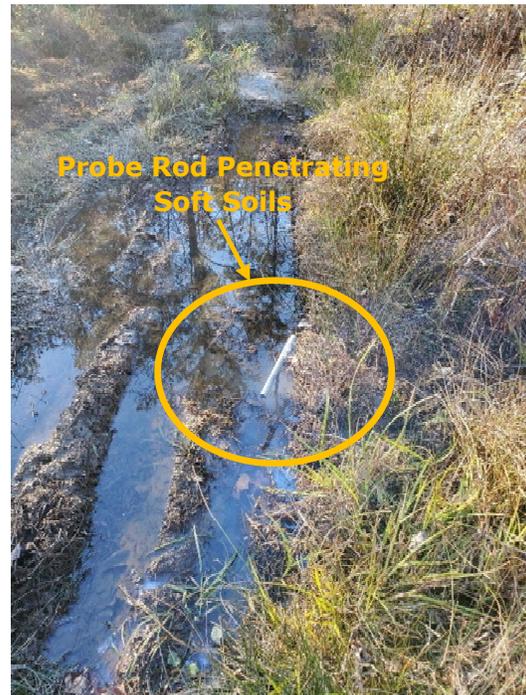
Figure 7: Water ponding and soft soils at toe of downstream slope

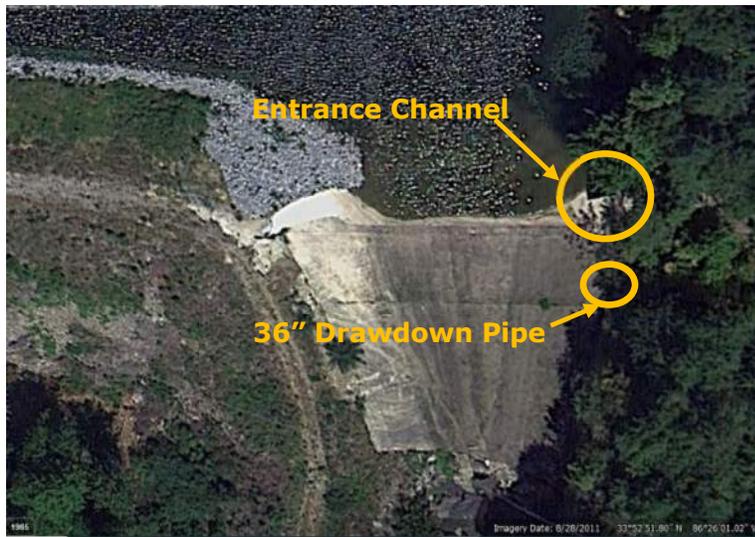
Figure 8: Concrete Spillway with Location of 36" Drawdown Pipe

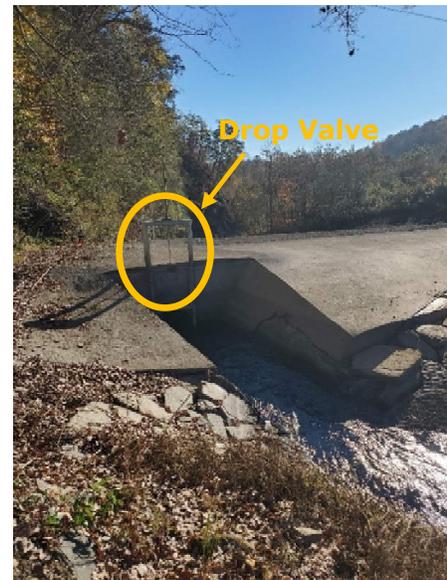
Figure 9: Entrance Channel for 36" Drawdown Pipe

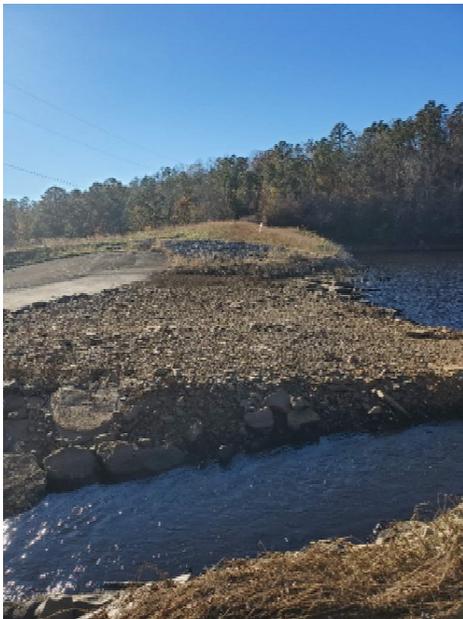
Description: Material consisted of boulders and sand. Visual geofabric was observed underlying the boulders.

Figure 10: Spillway Entrance Channel

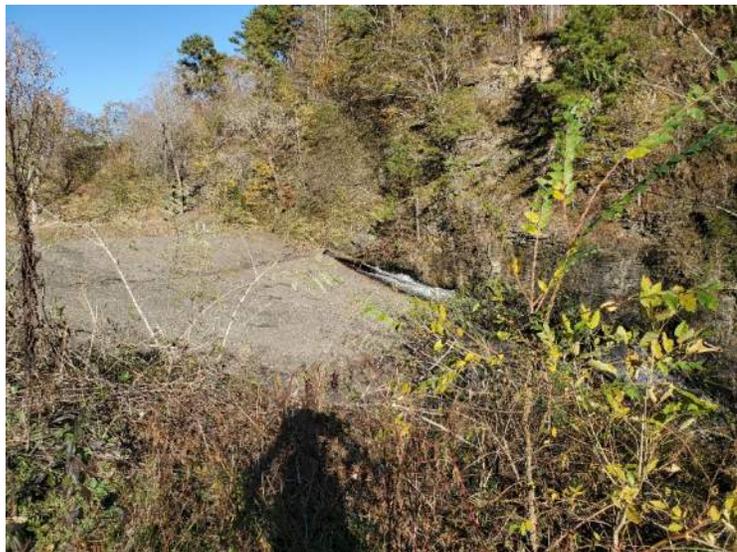
Figure 11: Downstream Apron with Secondary 36" Drawdown Pipe

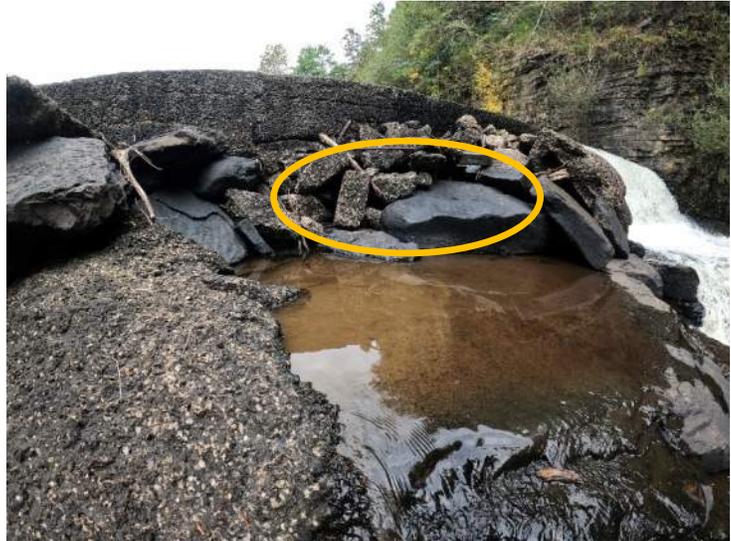
- Water seepage was observed between the toe of the concrete apron and the underlying sandstone. The seepage appeared to be flowing at approximately 5.0 gpm.

Unusual Conditions: Seepage observed between concrete apron and sandstone apron.

Figure 12: Seepage Location between Apron and Natural Sandstone

2. Water Seepage at Apron Toe: Water seepage was observed between the apron toe and the underlying sandstone. The water seepage is low and does not appear to be affecting the lake elevation. We understand larger water seepage issues have been observed in this area that required stabilization measures such as installing the concrete cutoff trench. The cutoff trench appears to be working effectively; however, we recommend monitoring the water seepage to determine if the seepage is increasing.

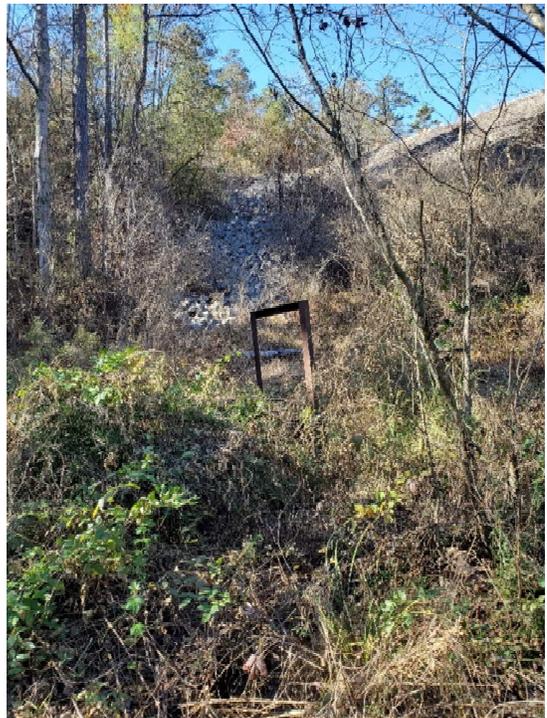
Condition of Material: very rusty

Seepage: slight seepage under the pipe. Estimated flow is 0.5 gal/min. The water was very muddy.

Figure 13: Apparent Abandoned Pipe in the Southwest Corner

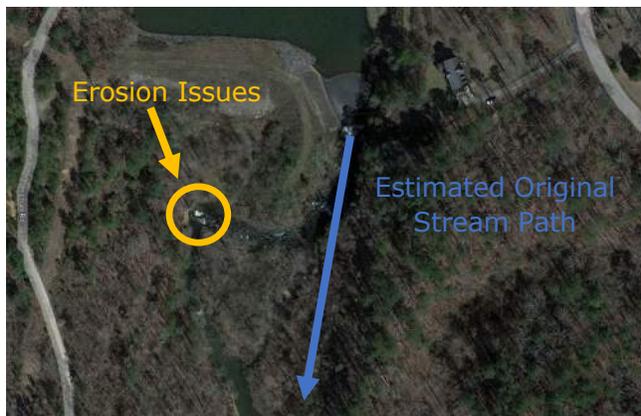
DOWNSTREAM CONDITIONS: Although not directly affecting the dam, the stream at the base of the apron had a number of erosion issues. Based on our field observation and discussions with John Hand and Joe Hayden, the following was observed in regards to the downstream conditions:

Figure 14: Downstream Conditions

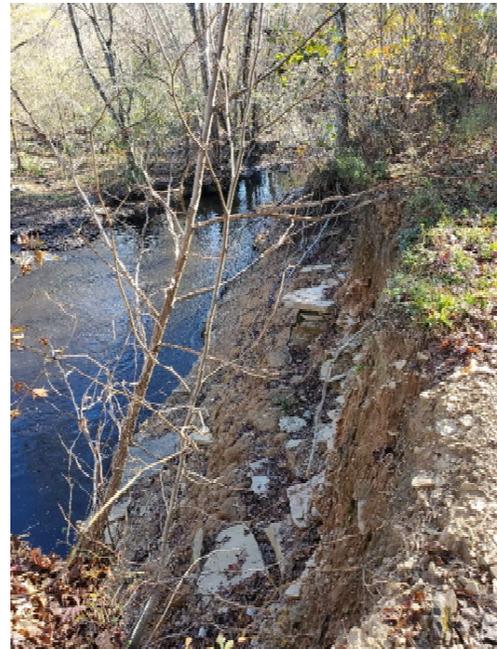
- According to Mr. Hayden, the down stream originally was straight during initial construction.
- During the re-construction of the spillway in the late 1970's, rock was blasted from the hillside, and a lot of the rock was piled downstream.
- The rock obstacles ultimately rerouted the stream to snake to the west around the rock debris.
- Because of the sharp curvature of the stream, major erosion issues are occurring where an access road is located (See Figure 15).

Figure 15: Erosion Issues Along the Stream
